Attachment No. 6 RMA Memoranda, Hydrogeologic Evaluation of Current Groundwater Conditions at the CEMEX Stillwell Quarry, March 24, 2014

SUBJECT: Hydrogeologic Evaluation of Current Groundwater Conditions at the CEMEX

Hydrogeologic Evaluation of Current Groundwater Conditions at the CEMEX Stillwell Quarry Tulare County, California

February 26, 2014

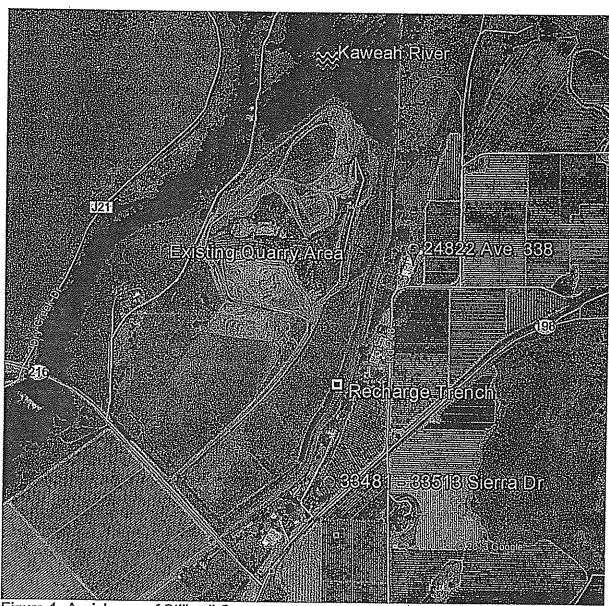
Figure 1. Aerial map of Stillwell Quarry area.

Figure 1 illustrates the location of the existing quarry excavation, the recharge trench, the 24822 Avenue 338 property, and the 33481 to 33513 Sierra Drive properties. Figure 1 was prepared from a screen-capture image from Google Earth. The imagery date for the aerial photograph in Figure 1 is June 15, 2011.

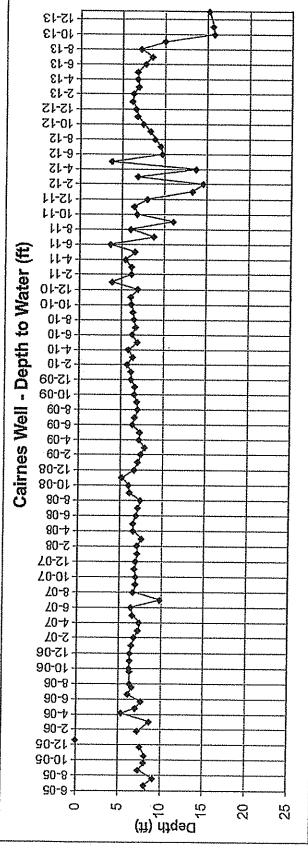
The data on Figures 4 and 5 indicate that the most rapid drawdown in the water levels in the wells at 33511 Sierra Drive and 24822 Avenue 338, respectively, began in August 2013, and that by October 2013 the water levels had stabilized and even recovered slightly.

Figure 5. Water levels versus time for the well at 24822 Avenue 338.

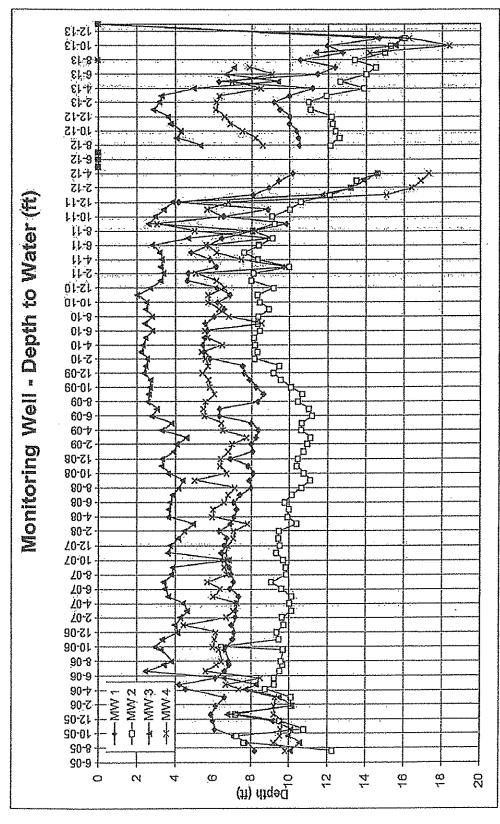
Figures 4, 5, and 6 show that the water levels in the neighboring wells and the onsite monitoring wells were relatively stable from 2005 through the middle of 2011. From approximately August 2011 until May 2012, the water levels in the wells decreased appreciably. The water levels subsequently recovered, peaking in January 2013 at levels that were within the same range as those that were measured in the wells from 2005 through early 2011. Since January 2013, however, the water levels have consistently declined in each of the wells shown on Figures 4, 5, and 6. In May 2012 and October 2013, the water level in the well at 33511 Sierra Drive (Figure 4) was actually slightly lower than the level measured in January 2014.

The data from the groundwater monitoring program, as shown in Figures 4, 5, and 6, indicate that declines in the water levels in the wells adjacent to the Stillwell Quarry occurred from August 2011 to May 2012, and again from January 2013 to the present. The most recent water levels measured in the wells is comparable to the levels measured in May 2012 and again in October 2013. Thus, the low water levels reported in the complaints discussed in Section 2.0 are not a recent incident and have been occurring cyclically since at least August 2011. The data clearly demonstrate that the groundwater level in the area was already dropping rapidly prior to the shutdown on September 4, 2013 of the pumps used for dewatering and for providing water to the recharge trench.

Figure 6. Water levels versus time for the onsite monitoring wells at the Stillwell Quarry.

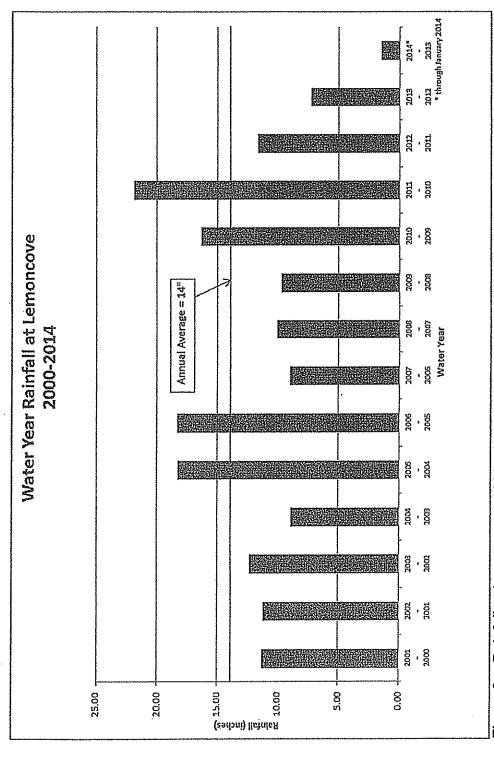
Figure 8 shows the water year rainfall in Lemoncove from 2000 through Jan 2014. Figure 8 demonstrates that the last two water years have been two of the driest ever recorded. Although the 2013-2014 water year is not complete, the first four months of this water year have been the driest October-January period measured in Lemoncove since 1923, based on the CDEC data.

Rainfall at Lemoncove, 2000-2001 water year through January 2014. Figure 8.

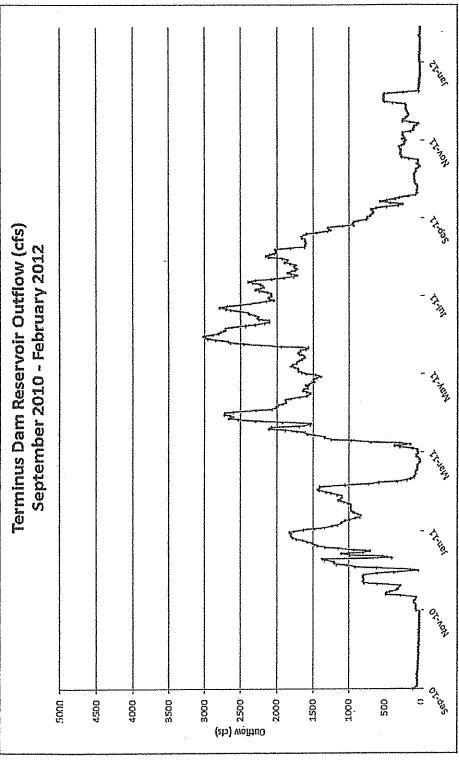
River for the 2010-2011 water year, and extending into early 2012. Flood releases occurred almost constantly from early November 2010 through February 2011, with a peak rate of almost 1,800 cubic feet per second (cfs). Irrigation releases occurred continuously from early March 2011 until the first week of October 2011, with a peak rate of almost 3,000 cfs.

Figure 10. Releases from Terminus Dam to the Kaweah River, September 2010 to January 2012.
