SENATE BILL 244: PART II

DISADVANTAGED UNINCORPORATED COMMUNITIES ASSESSMENT

OCTOBER 2015

VRPA Technologies, Inc.
4630 W. Jennifer, Suite 105
Fresno, CA 93722
Project Manager: Georgiena M. Vivian

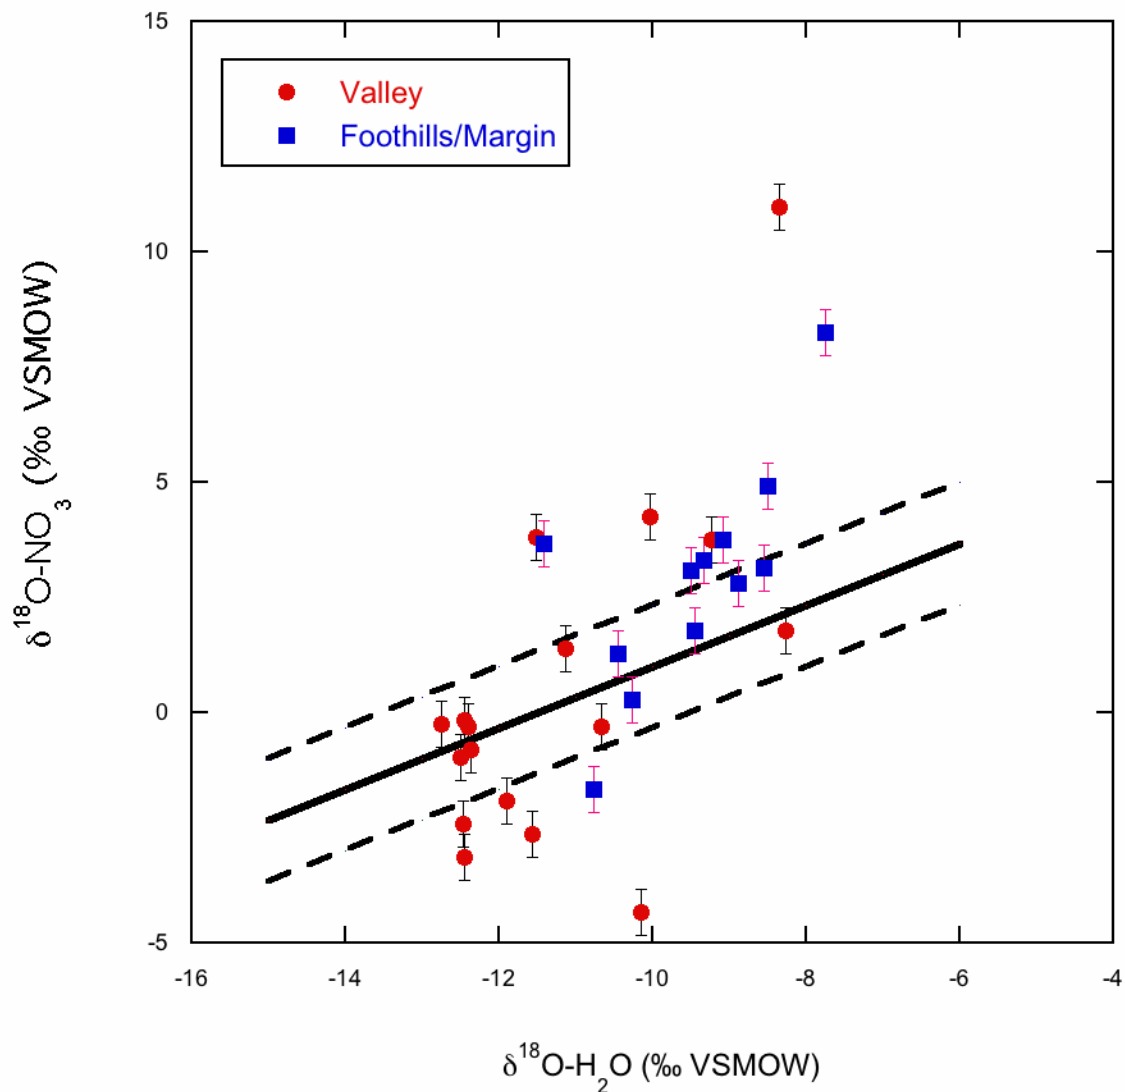
Figure 10. Oxygen isotope compositions in water and nitrate from Tulare County domestic wells. The predicted relation between oxygen isotope compositions in water and nitrate produced by nitrification of ammonium are shown (solid line) with additional lines to account for a range of $\delta^{18}\text{O-H}_2\text{O}$ values that may occur in unsaturated zone pore waters where nitrification is likely to occur (dashed lines).

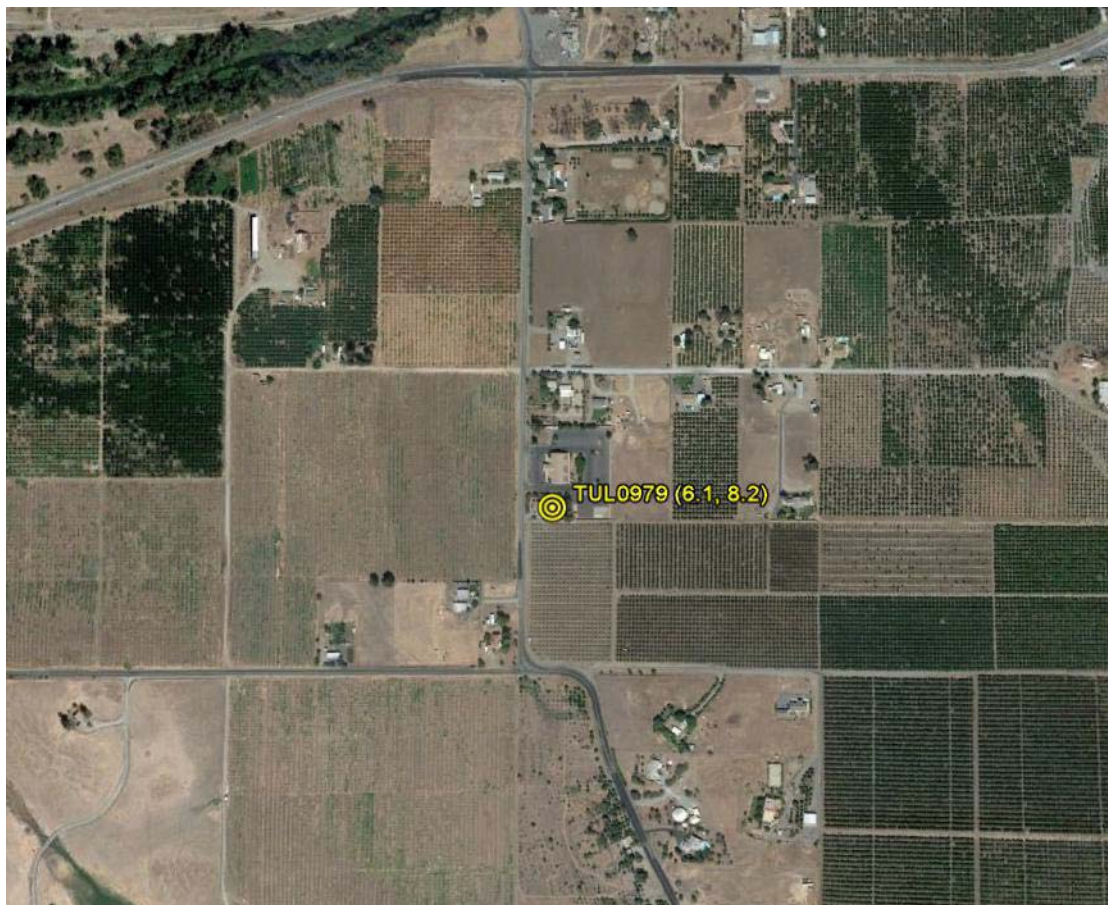
Figure 12. Location of well TUL979 on a Google Earth 2010 satellite image. This foothill well (elevation 546 feet) is in a sparsely populated area surrounded by orchards and has high nitrate concentration (240 mg/L nitrate). The nitrate isotopic composition ($\delta^{15}\text{N}-\text{NO}_3= 6.1$, $\delta^{18}\text{O}-\text{NO}_3= 8.2$), in particular the high $\delta^{18}\text{O}-\text{NO}_3$, is indicative of a synthetic fertilizer source.
